SYRACUSE INSPECTIONS
& PROPERTY SERVICES, INC.

Home Inspection Report

Prepared for:
Jack Smith

123 Jones Road
Syracuse, NY 13201

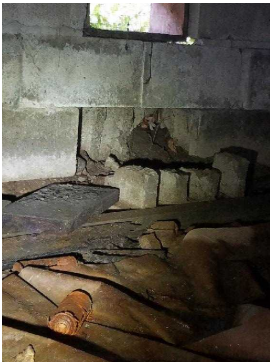
Foundation Walls: Masonry Block - Dislodged/deteriorated block at vent, obtain estimate for repair from a qualified contractor.

3. Rear Crawl Space Foundation Walls: Masonry Block - Dislodged/deteriorated block at vent, obtain estimate for repair from a qualified contractor.

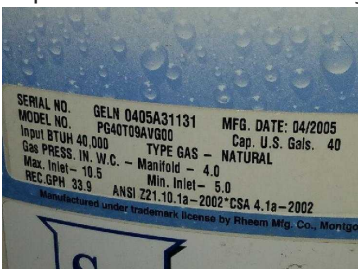
- Water Heater Operation: Gas hot water tanks normally last 8-12 years, unit is 16 years old, replacement could be at any time
- Flue Pipe: Single wall
- Temperatur/Pressure Relief Valve:
- Fuel Lines:

4. Water Heater Water Heater Operation: Gas hot water tanks normally last 8-12 years, unit is 16 years old, replacement could be at any time
